Inspection Report

Mine Name: Reef

Operator Name: Castle Valley Stone

Permit number: S0150094

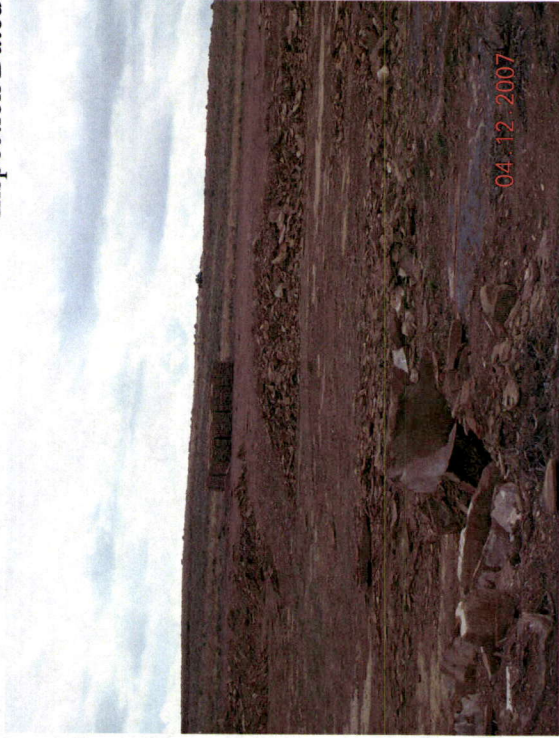
As far as I could determine, no grading was done in response to my recommendations after the most recent inspection. Photos 1 and 2 are overviews of much of the site. Waste was graded over most of the area, but there are some areas where the underlying rock is exposed. The waste was not feathered. Rather, it begins and ends abruptly. There are still several pallets of stone and compacted areas over which people have been driving.

Photo 1. Near the center of this picture are several pallets of stone, and one can also see compacted areas over which people continue to drive.

If the operator is truly reclaiming this site, the palletized stone needs to be removed, compacted areas ripped, the waste feathered into areas with no waste or soil, and since much of the site will be redisturbed, much of it will need to be seeded again.

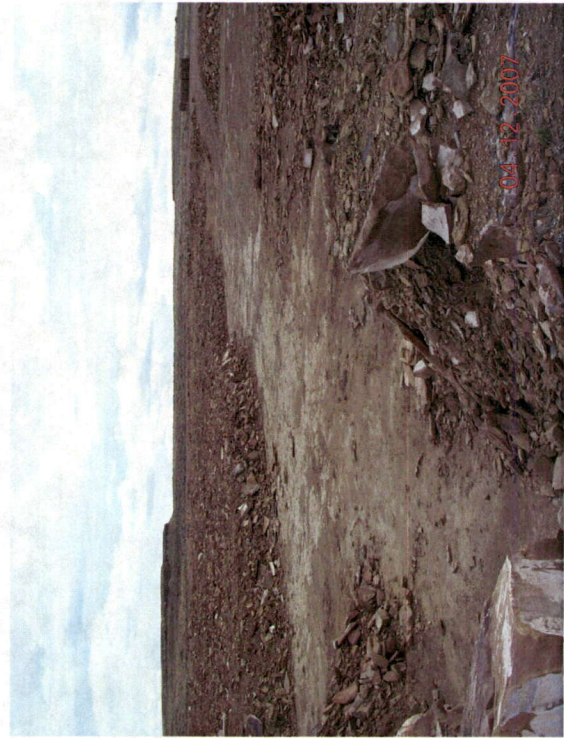
Photo 2. Note how the waste material on the left of this photo ends suddenly. The area to the right of the waste is exposed bedrock.

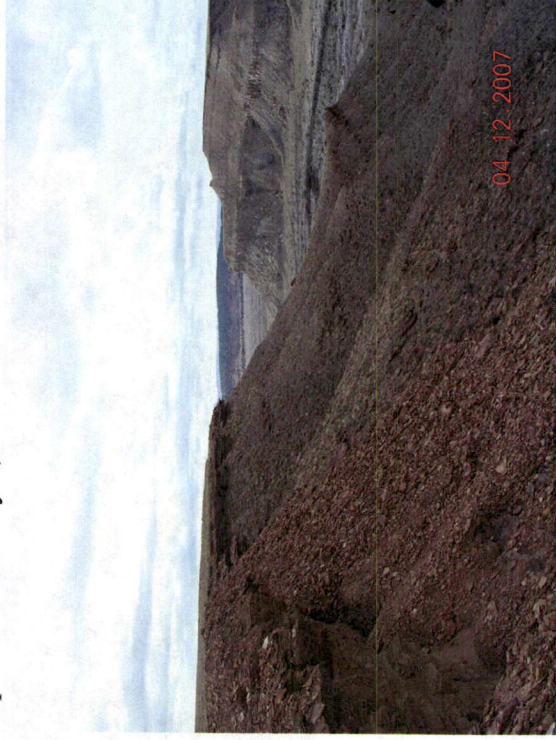
Photo 3. Waste was pushed over the edge of this cliff.
